**Memorandum**

Document Control Number: mm004

Subject: Town Brook Enhancement Project - Quincy – Site Visit 3.11.13

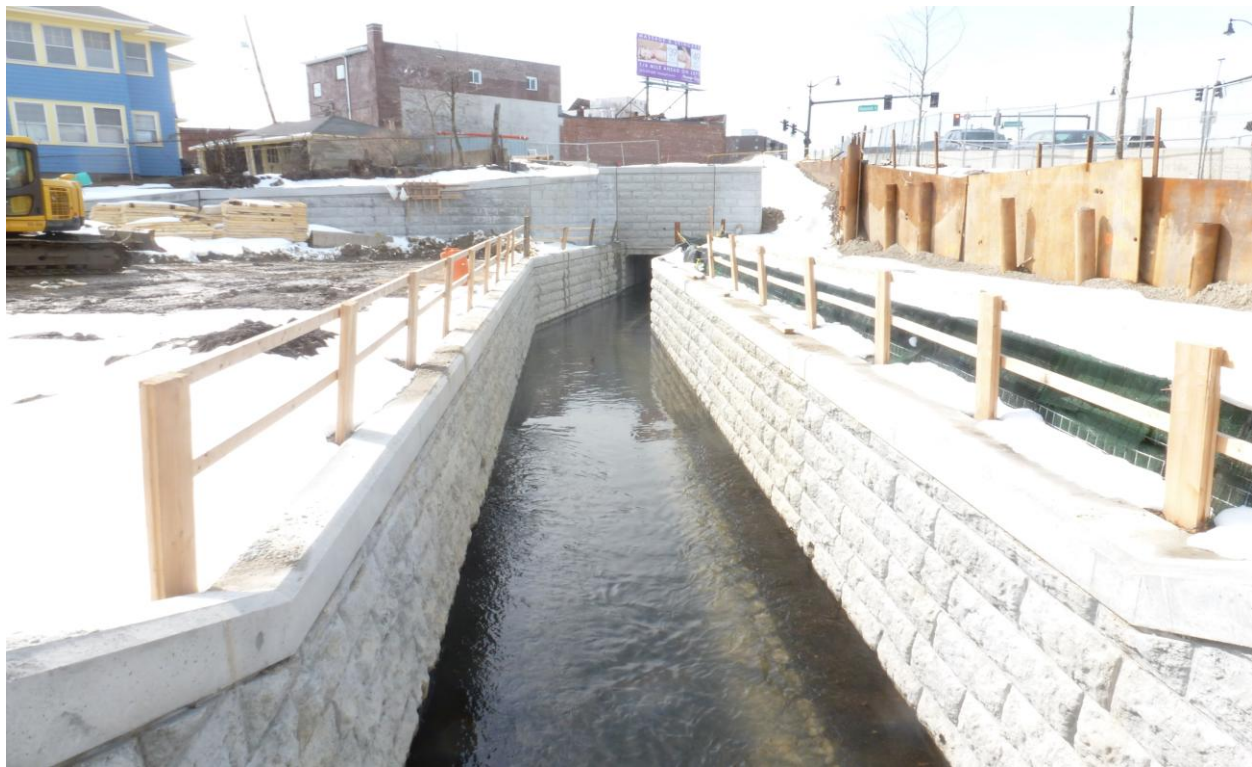
1. Park Area, Station 23+00 to 24+50. River flows are above planting area. Note Plantings to occur after June 1<sup>st</sup>. See Picture 8-1.

Picture 8-1 – Flow in constructed channel – Station 23+00 to Station 24+50

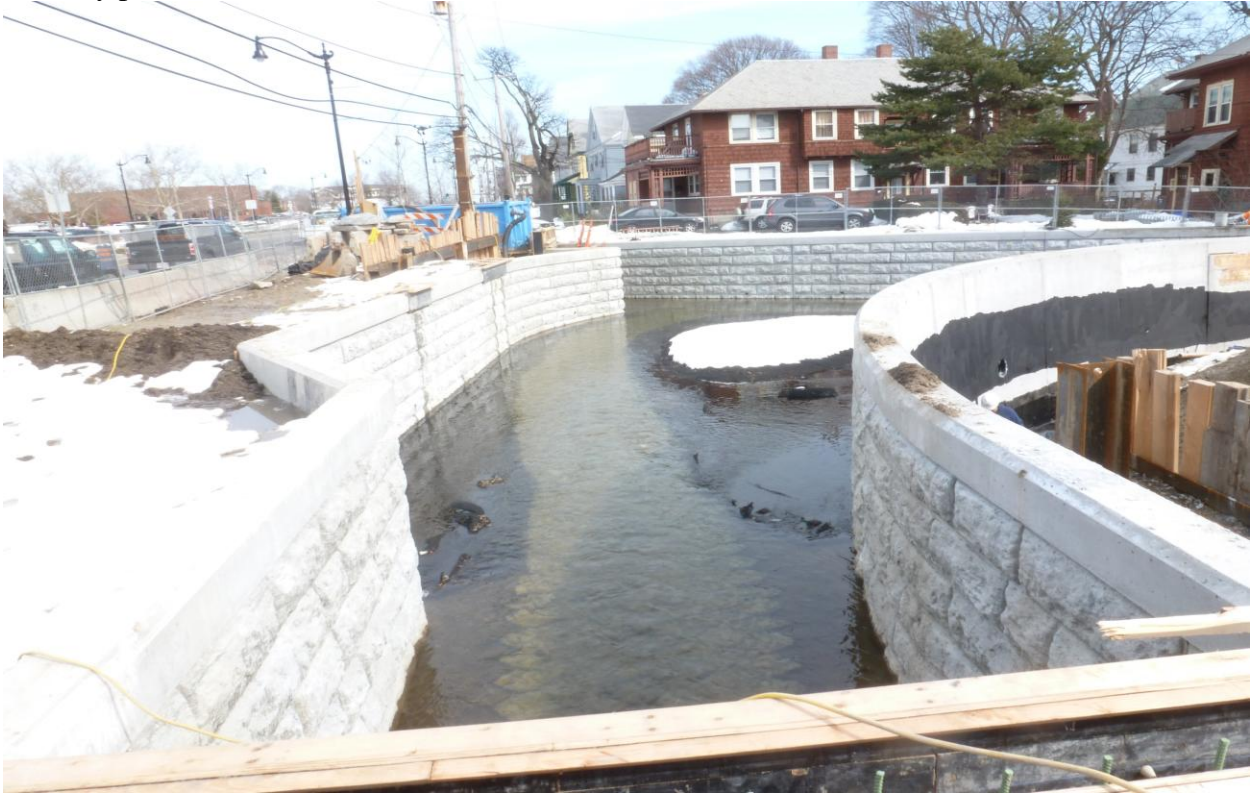
2. South Channel Wall Station 21+50 to Station 22+00 complete. Channel substrate has been installed including planting island. Note some geotextile channel lining has become dislodged. It is noted that a group meeting with DEP, DMF, and Quincy officials have

Picture 8-2 – Completed Concrete Channel South Wall, Channel and Island substrate installed . Sta.21+50 to 22+50

determined addition of heavy stone will assist in securing the dislodged channel lining and may provide some riffles. See Picture 8-2.

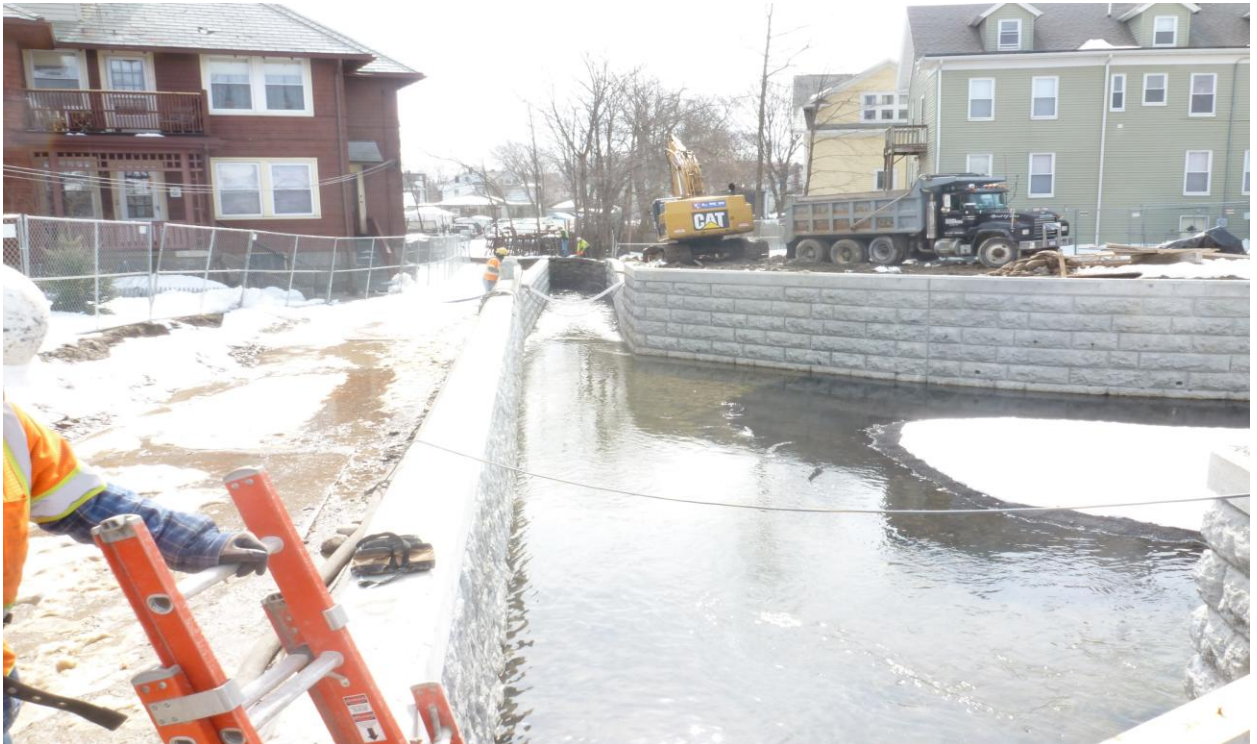
3. Work on existing wall and finish work on new channel wall Station 20+00 to 21+50 continues. See Picture 8-3.

Picture 8-3 Over view Sta 20+00 to 21+50.

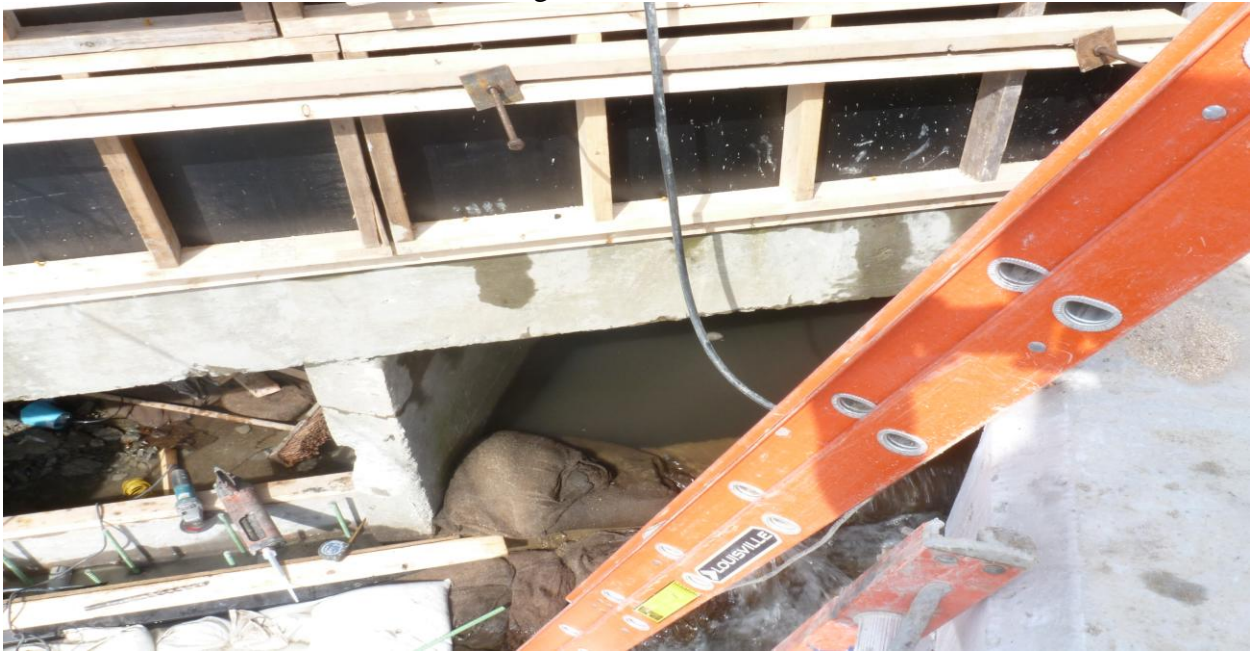
4. High turbidity observed in existing Town Brook Culvert. Low flow from existing culverts adds visible cloudiness to existing Town Brook flows. See Picture 8-4,8-5.

Picture 8-4 Existing Town Brook Culvert.

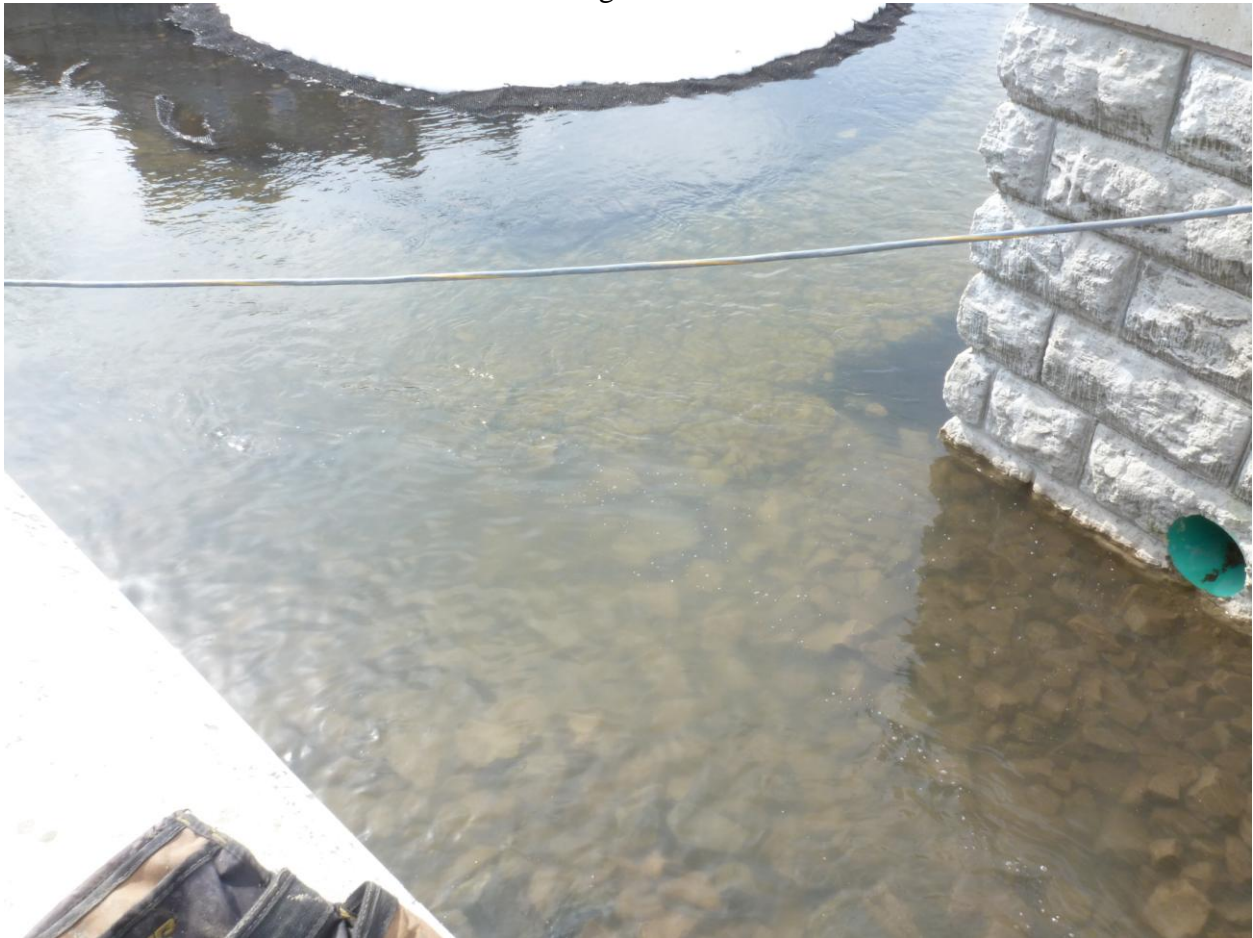
Picture 8-5A Existing Town Brook flows meet new Town Brook Flows.

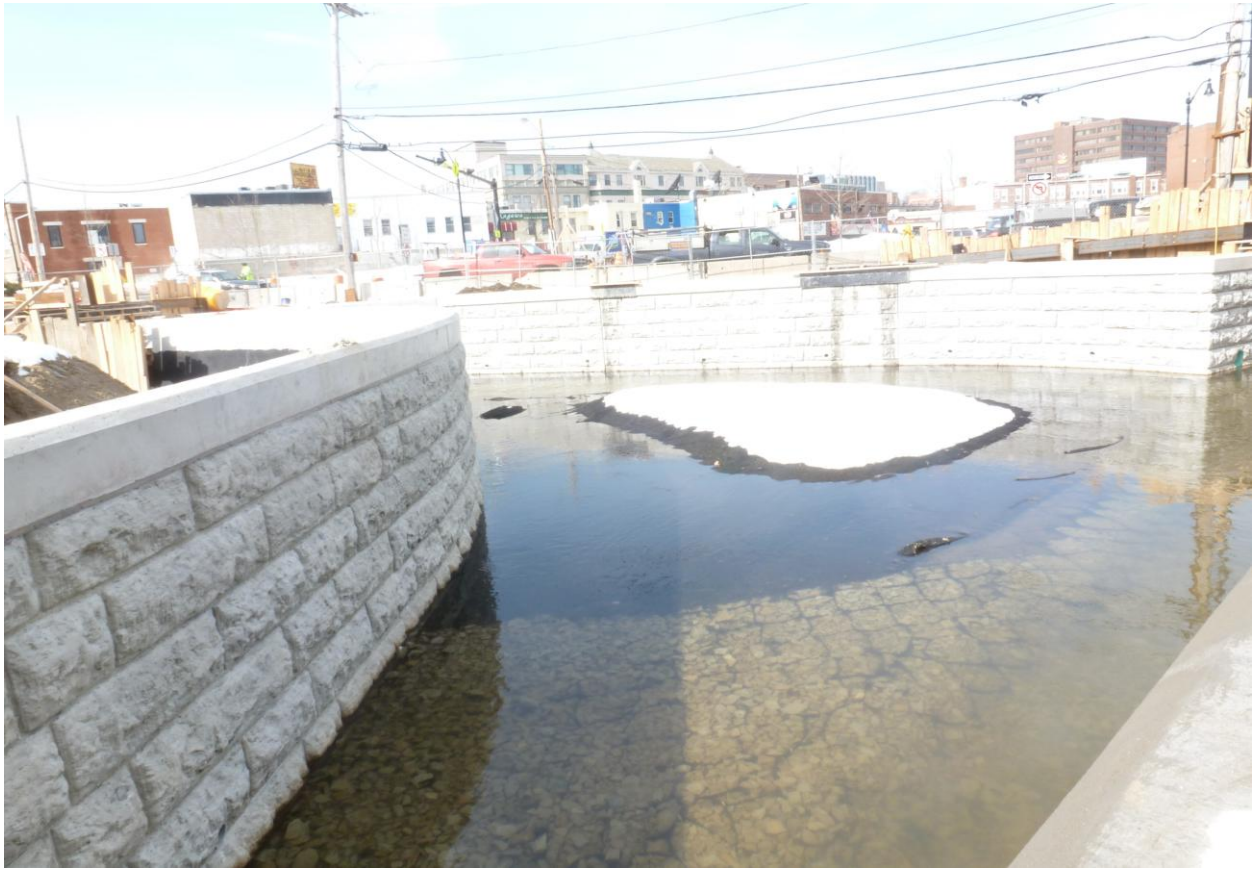
Picture 8-5B Existing Town Brook flows meet new Town Brook Flows, Note dislodged channel lining to be stabilized.

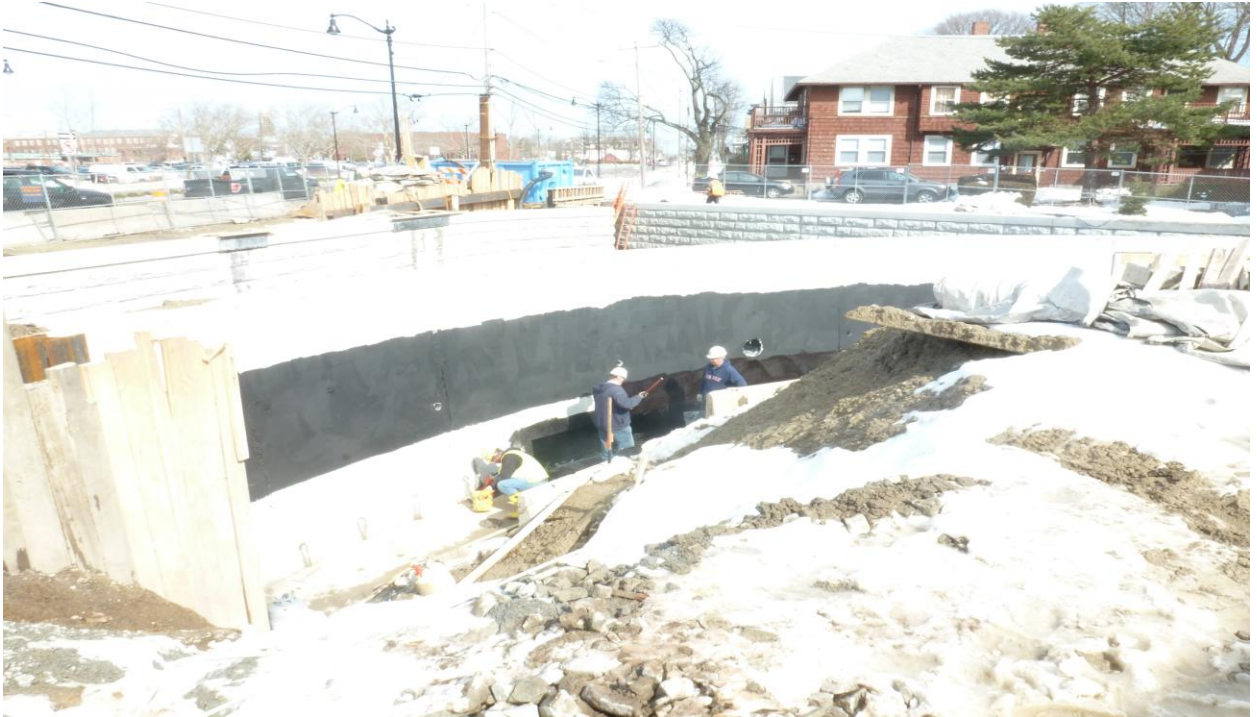
5. Water Proofing of South Channel Wall 21+50 to 22+50 Continues. See Picture 8-6  
Picture 8-6

Picture 8-6 Water proofing south channel wall.

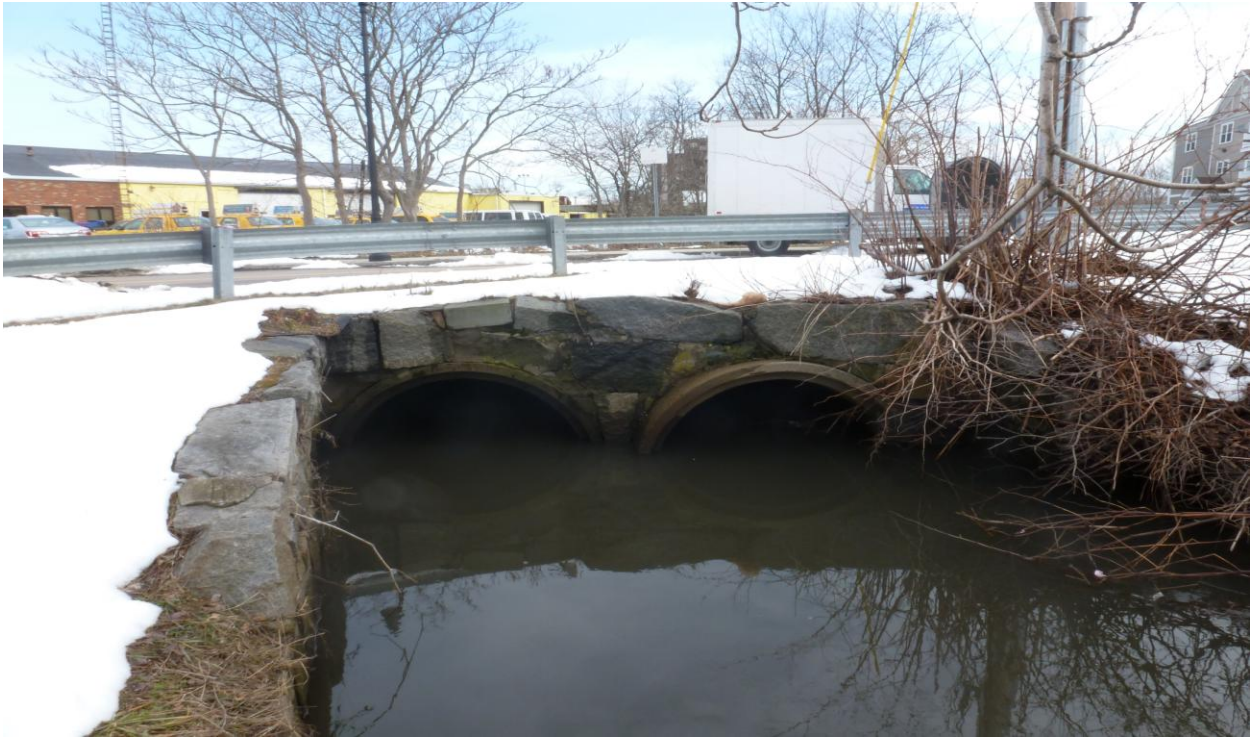
7.

Picture 8-7- Town Brook at Elm Street, a down stream location. It is noted that the turbidity of Town Brook was much higher at this location.
